**FINAL TECHNICAL REPORT 4002011**  
**May 1998 – February 1999**

## **FIELD EVALUATION OF THE IONIX STATIC ELIMINATOR**

NICOR TECHNOLOGIES  
1784 FERRY ROAD  
NAPERVILLE, IL 60563  
(630) 983-8676

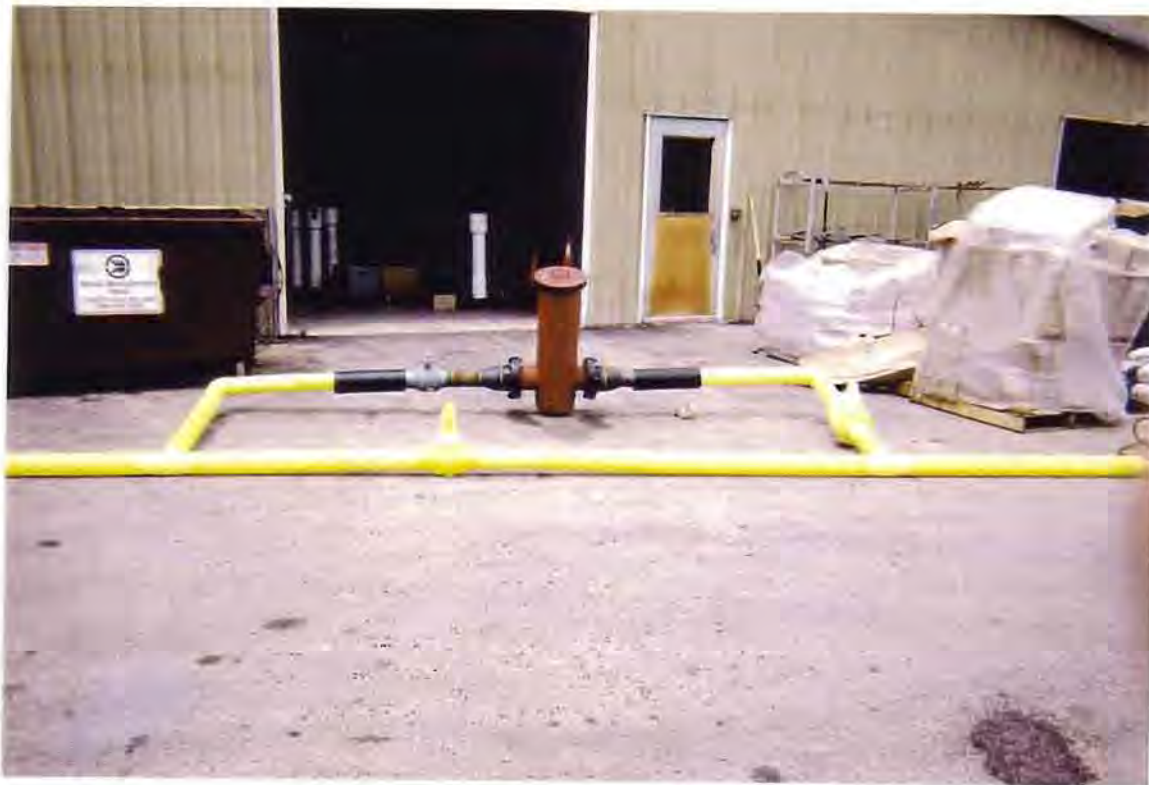
Photograph 1

The 6" nozzle size Ionix unit (SGFTJR6) was initially assembled at Nicor Gas' Crystal Lake facility (See Photograph 1). Once the assembly was completed and pressure tested for leaks, the prefabricated unit assembly was taken out to the installation site. At the time of the installation, two stops were dropped on either side of the existing 4" PE distribution pipe and the existing section of PE main was removed. Next, the unit assembly was electro-fused in the place of the old pipe (see Photograph 2). After allowing sufficient time for cooling, the bypass valve was opened and the gas allowed to flow through the new pipe, bypassing the Ionix unit. At this point, the Ionix filter membrane was placed within the casing (see Photograph 3), after which the inlet and outlet valves were opened and bypass valve closed, to initiate gas flow through the Ionix Anti Static Unit.
